FACILITY COMPLIANCE INSPECTION REPORT

Date of Site Inspection: 4 January 2012

Miller Farm LCID Landfill
Miller Farm Road
Morehead City, NC 28557

Site visit to review continued measures taken in response to 19 December 2011 fire event

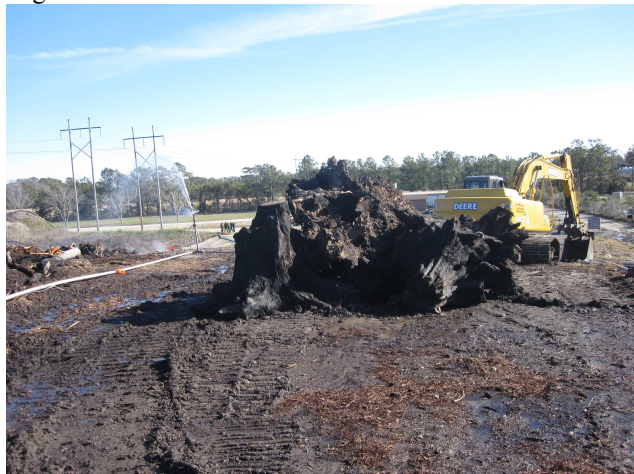
Top of landfill-note sprayer, hose, and dowsed excavated materials

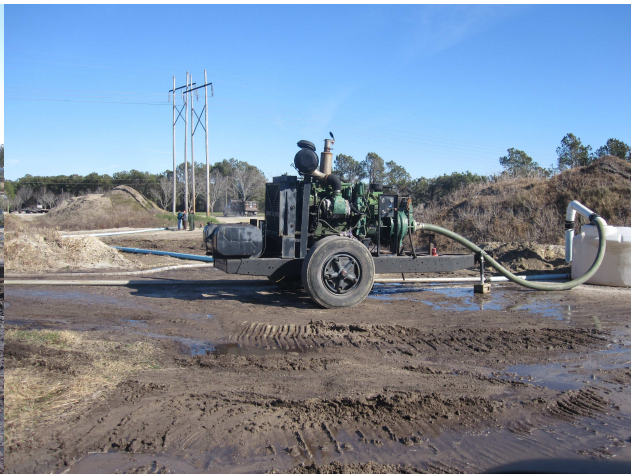
- 13) One PTO driven pump mounted on a tractor, another diesel powered pump, and three agricultural type sprayers have been put in place to pump water onto the landfill. Both pumps and all three sprayers were in operation during this site visit.

Diesel powered pump in operation

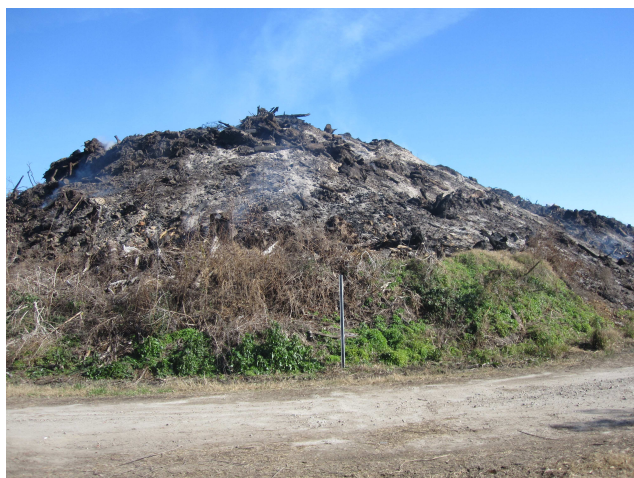
Landfill cover crop and cap damage from fire and excavation-note minimal smoke

- 21) *As soon as is safely practicable, please resume compacting and covering the landfill cap and sideslopes damaged during the fire incident. Once the repairs are completed, all sideslopes should be graded at a slope not greater than 3:1 and seeded and mulched to establish a groundcover suitable to prevent erosion.

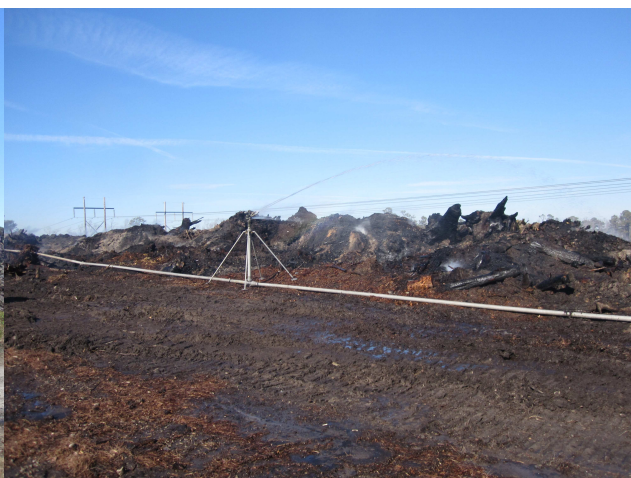
Piping, ag-type sprayer wetting excavated material on top of landfill

- 15) Excavation and spraying operations were underway during this site visit.
- 16) *As is safely practicable, please continue excavating and pumping water onto the landfill until the fire is completely out.
